Rome Ancient Walls Satellite Monitoring Project

THE ROME WALLS CASE STUDY

PS INSAR MONITORING

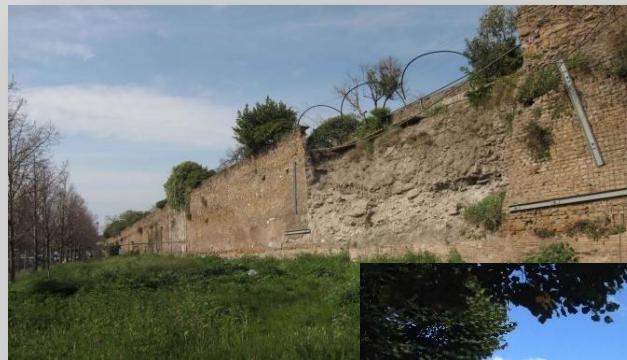
Collapse (2007) and restoration

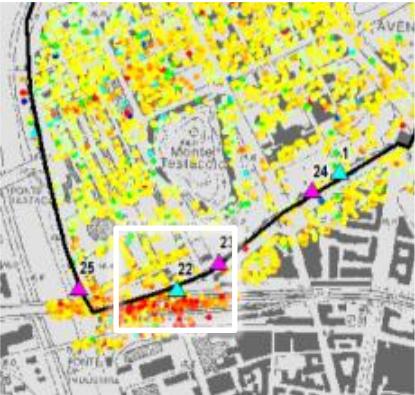
Wall cover detachment due to train transit on the railway.
Restored in 2012.
